Stream Team Report

Mowry Brook Marlborough, Massachusetts Study Conducted June-July, 2007

Submitted
November 10, 2007
By Jennifer Boudrie
Jen@GreenMarlborough.org
T 508-481-0569

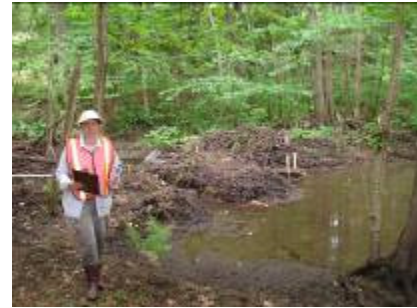
Crossing Spoonhill Avenue, the area broadens into a wetland and forested area.

On one side is a very large apartment complex that abuts the wetland. The stream bank has some plastic and metal debris mixed in with the plants and bushes. Brown polluted water is visible. Near the apartment complex are houses. Behind two houses were large leaf piles from home owners.

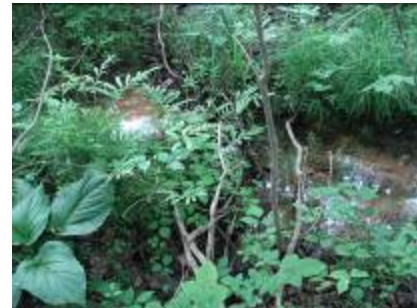
Further downstream there is 12-foot-high vegetation (reeds). The stream was too muddy/mucky to walk in so we walked the bank instead. We could not see the stream for several hundred yards. When we could see it, the water flowed slowly.

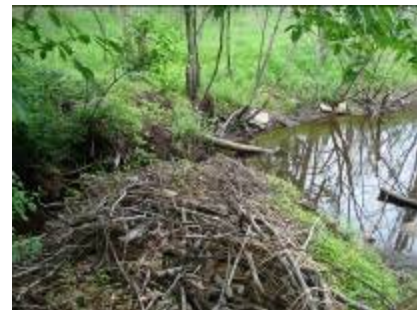
The wetlands end near Stow Road and the stream enters a developed area with houses. Behind the house at 58 Stow Road is a beaver dam. It was breached so the water could flow through it but there is still lots of debris.

Blockage from beaver dam debris, and a broken wooden bridge could potentially block the stream.

Maybe clean up the beaver debris by Stow Road. The owner of 58 Stow Road wants more of the beaver dam debris removed because trash from the apartments collects there.

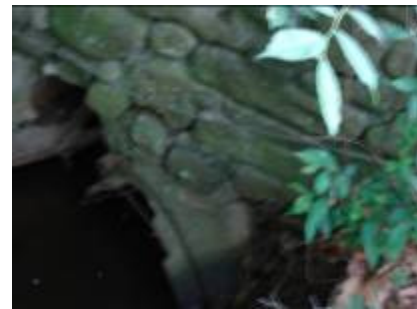
Near Stow Road the stream flows through a driveway culvert. Debris collects there and is slowly eroding the driveway. The culvert is too small during floods.

Eroding culvert under the driveway on Stow Road.

The culvert under the driveway is too small. It is eroding and partly blocked by beaver debris that washes downstream.

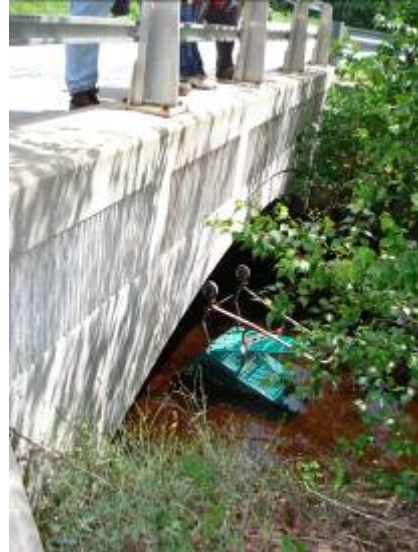
This grated culvert is behind Gotham Ink and the large apartment complex. It catches debris that is washed downstream. At this point the stream disappears underground for some distance and reappears by Phelps Road.

The overflow pipe in the right of the photo runs under a large parking lot in the apartment complex and dumps into a large marshy conservation land area on the other side of the parking lot.

Behind Gotham Ink and Route 20 there is an apartment parking lot and Mowry Brook flows underground into a grated culvert there. **Trash** from the Price Chopper plaza gets washed downstream to this grated culvert. **Flooding** of the parking lot occurs during heavy rain/snowmelt runoff because this culvert is too small to handle the runoff. The **overflow pipe** dumps into a large marshy conservation land area on the other side of the parking lot.

Evaluate the culvert and overflow in the apartment parking lot behind Gotham Ink and Route 20.

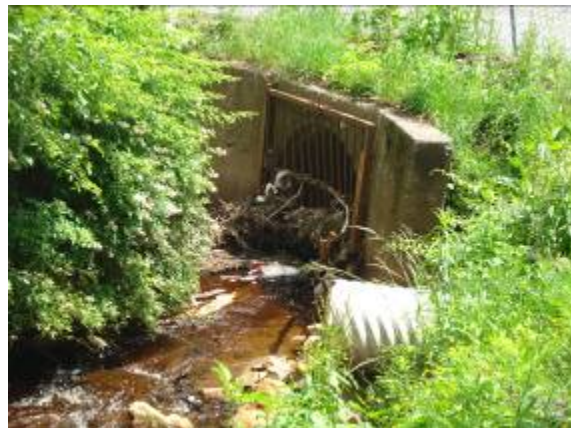
Trash from the Price Chopper plaza gets washed downstream to this grated culvert.

A former employee of the apartment complex cited occasions when the stream rose above the culvert and flooded the parking lot. It is possible that since the year this culvert was installed, development and runoff has increased and this culvert is no longer adequate to handle the runoff.

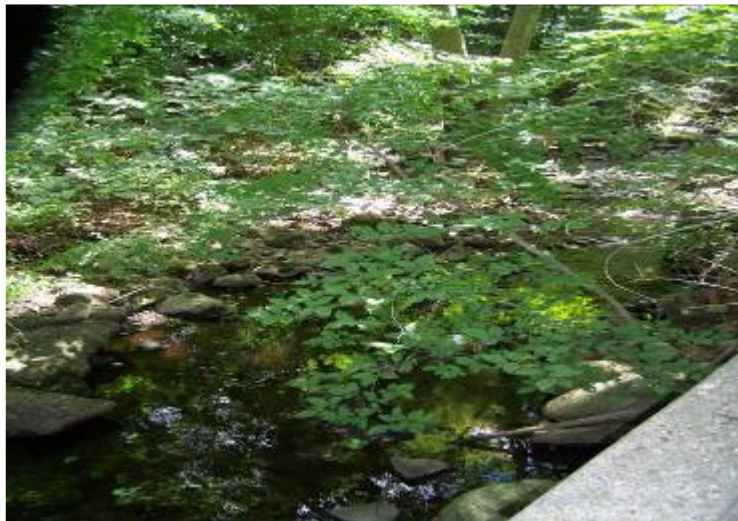
Lots of beer cans, etc. down very steep slope...hard to reach area...also large blue plastic pool noted on 8/18/2007

(Photo August 18, 2007) looking down steep wall Phelps Street

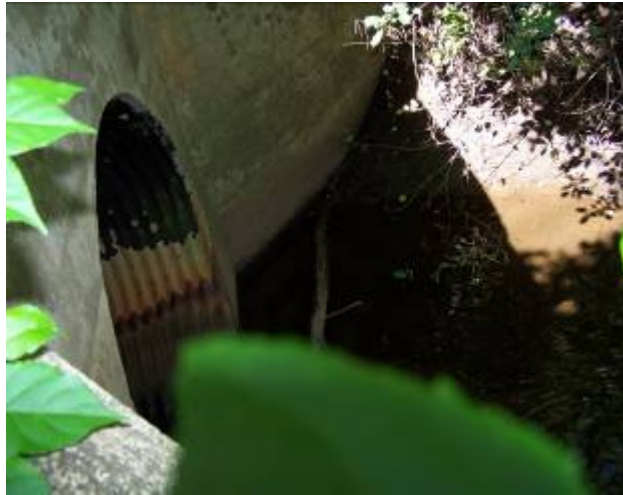
The stream had meandered through thick low vegetation – lots of marshy areas visible. Lots of “skunk cabbage”. Sounds of many birds. Culvert in good shape except for 3-4 branches lying across the front of it. Sights of deer (?) footprints.

Photo taken August 18, 2007 (large stick in front of culvert) Royce Road

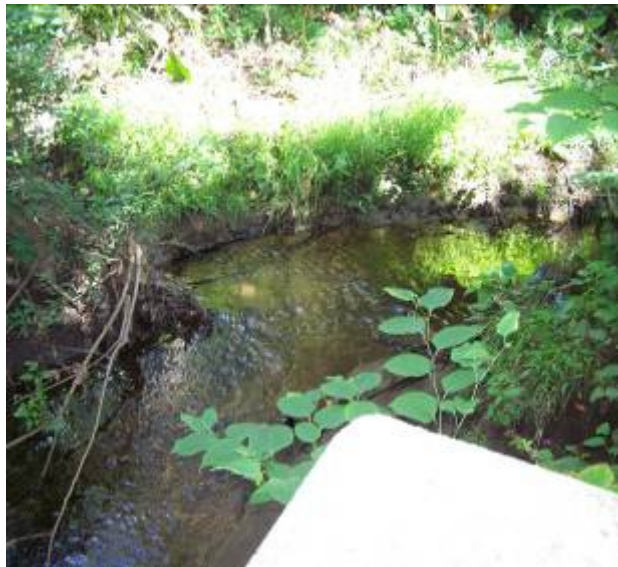
Photo taken August 18, 2007 Royce Road

DEP 212-717: Sign on Royce Road mostly covered by recent growth.

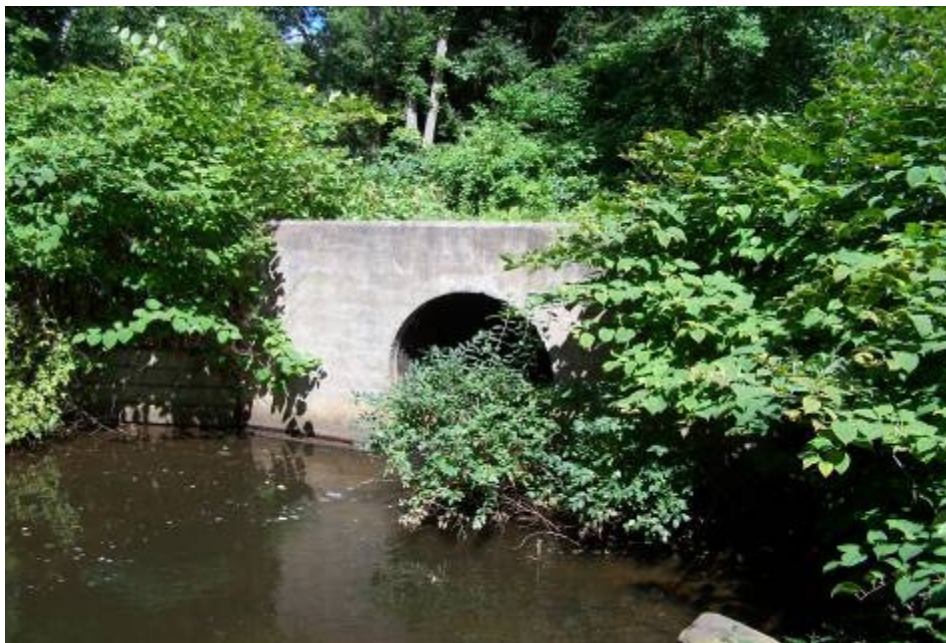
(Photo taken August 18, 2007) Royce Road

River flows slowly through here. Left bank is sloped from an abutting lawn. Right side goes into wet areas. The left side of the retaining wall shows a high amount of erosion and probably allowing lots of run off from the street. Water is cold. Very small amount of trash.

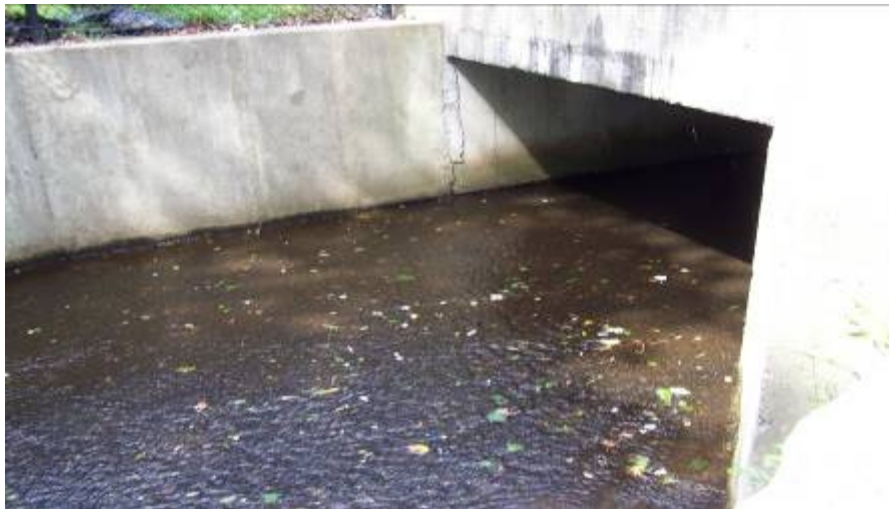
Farm Road South Side

South side of Route 20, the early part of the stream bottom appeared to be concrete. Lots of moss/algae like vegetation in this fairly shallow area. Lawns to left side; right side more low foliage. Stream continued down into more wooded area.

Inside the culvert was another pipe coming in perpendicularly; about 2 feet up above floor of culvert. Culvert in good condition.

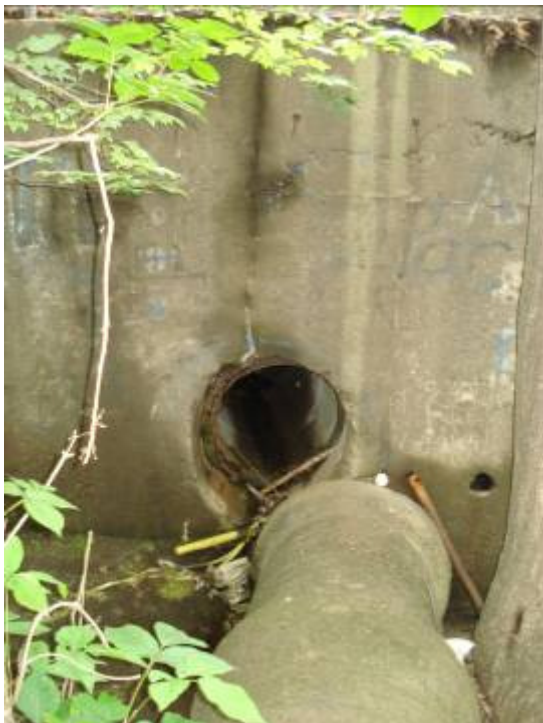
Behind the apartment complex (the apartment numbers # 48 and #49 were visible) there is a 2-foot storm drain disconnected from the concrete wall. One hundred feet from the wall and near the stream is a brown, rainbow glossy oily discharge from the direction of the concrete wall.

Damaged drainage behind apartments on Hosmer Street

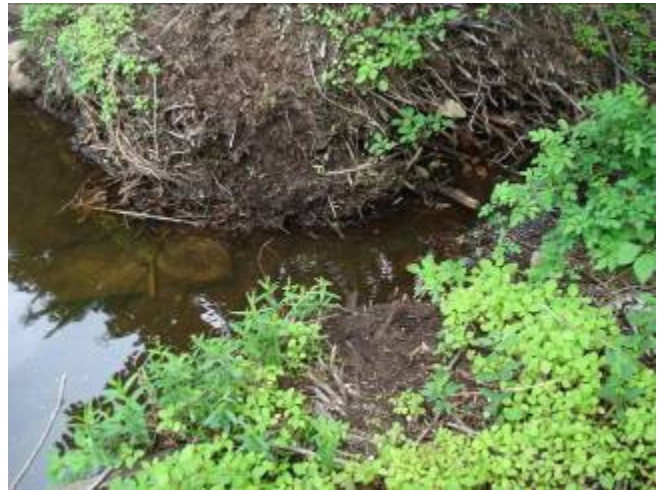
Beaver Dam by Stow Road

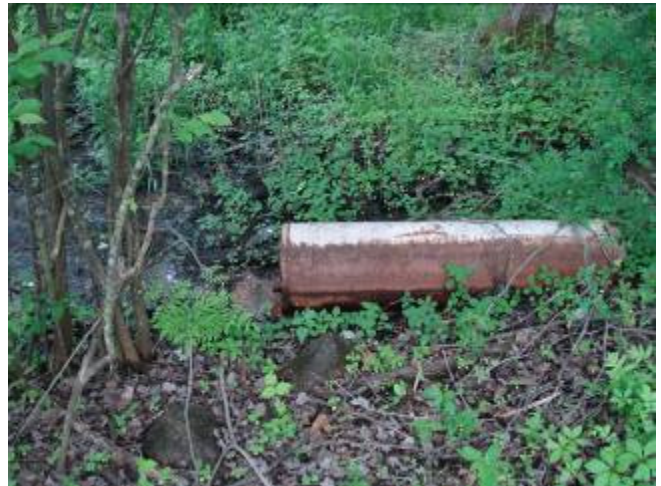
Debris by Stow Road

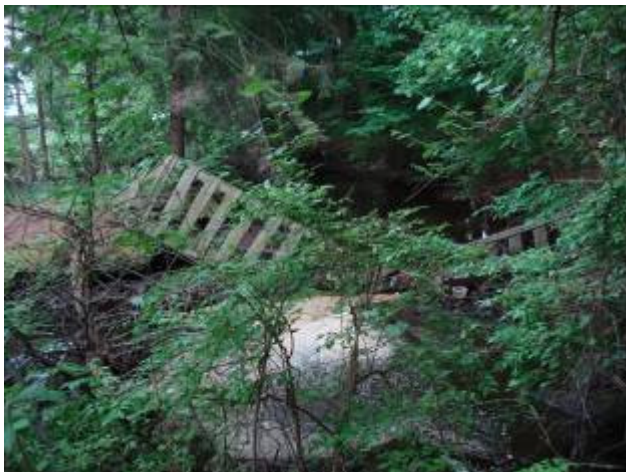
The broken wooden bridge by Stow Road could be a hazard or blockage at some point.

Broken wooden bridge by Stow Road

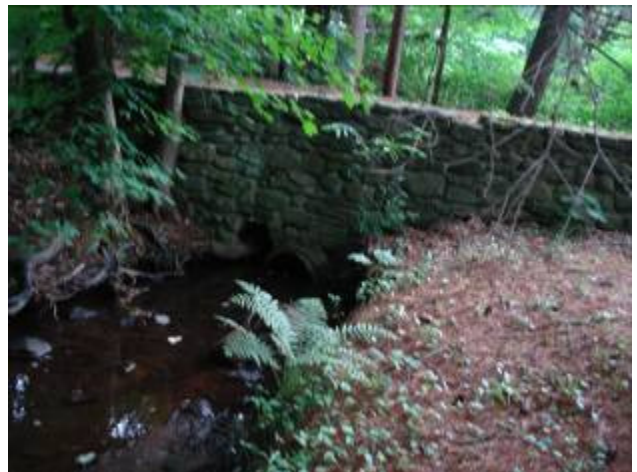
Damaged culvert under driveway bridge by Stow R.
